European Union Network for
the Implementation and Enforcement
of Environmental Law

Waste Sites II

Final report:
21 November 2014

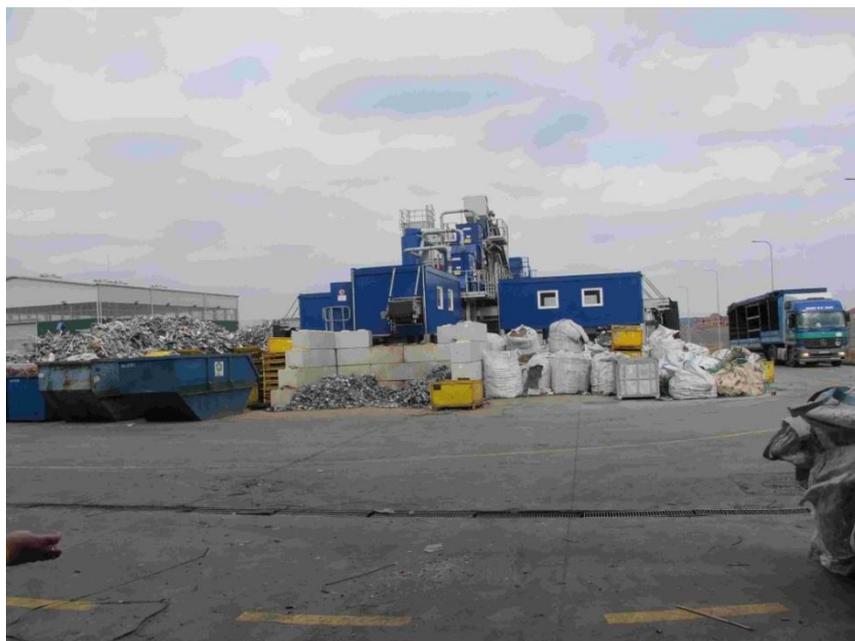
Photo:
Recycling company in
Frumuseni (Arad county)

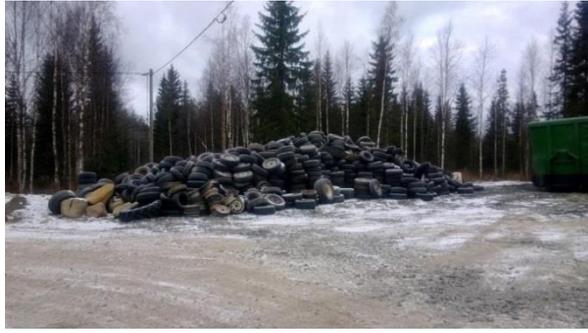
(Photo: Waste tyres in Tornio, Northern Finland)

As a result of the inspection it was found that the company had the necessary waste permit for trading and transporting metals, end-of-life vehicles, used tyres and batteries in Finland since June 2013. Most of the waste comes from Northern Finland but some is also imported from Sweden. The company had also applied for an environmental permit from the City of Tornio for the intermediate storing of end-of-life vehicles and the receiving and collecting of waste batteries and accumulators. The company did not drain vehicles on their properties but planned to start this business, so they applied for the relevant permit from the Lapland Centre for Economic Development, Transport and the Environment. Besides, it was envisaged to establish a subsidiary company in Sweden for the draining of cars before they are transported to recycling companies in Finland. Contracts with Finnish companies for the adequate recovery of used tyres and waste accumulators existed, and all types of waste were appropriately stored on the site.

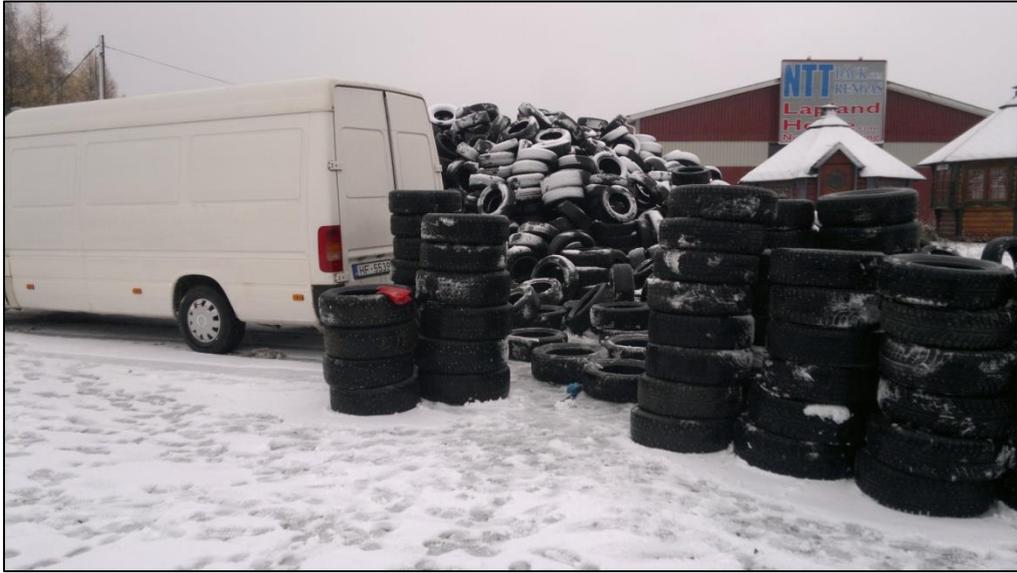
When approaching the outskirts of Haparanda it was observed that a few men were loading a white van with discarded tyres. It was a Latvian van and it turned out that its occupants had permission from the local garage to take the tyres. Since tyres are not classified as hazardous waste under Swedish law and they were not stolen the police could not intervene. The Haparanda environment inspector, however, contacted the company and informed them that they are not allowed to dispose of their old tyres in this manner. Should their practice not be discontinued they would be subject to fines from the city council.

(Photo: Latvian van loading discarded tyres in Haparanda, North Sweden)

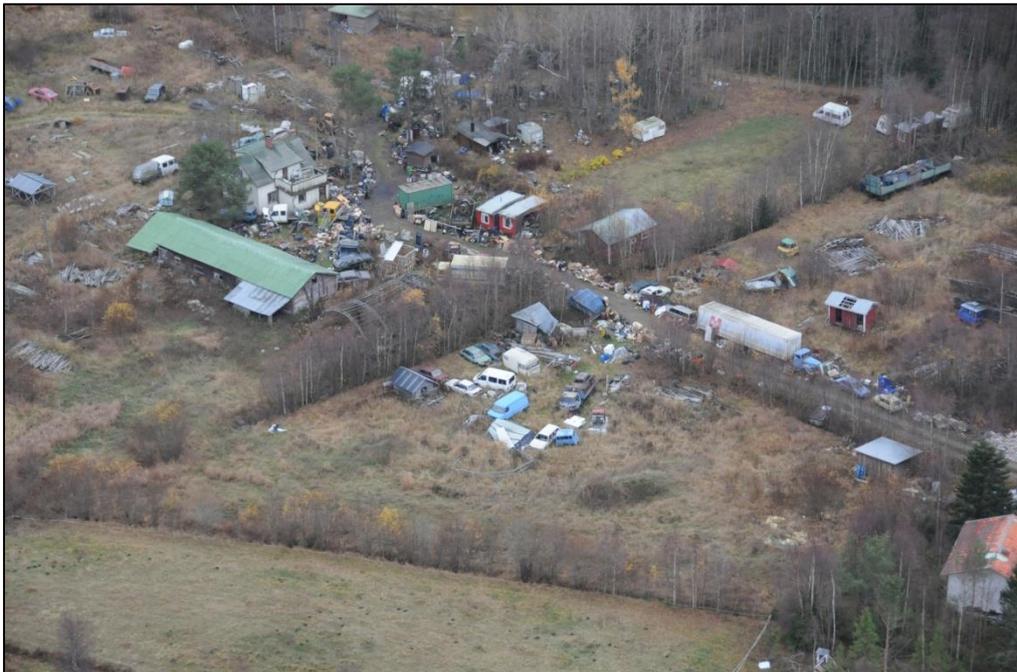
The illegal waste site that was then controlled south of Haparanda has been a problem for the local authorities for over a decade. The man who operates on the facility consistently refused to cooperate with the authorities and to follow their instructions. The situation has deteriorated since 2009 in such a way that action was necessary. The property used to be owned by the man's mother (now deceased) and the local council is worried that they will have to pay for the sanitation of the estate should the operator abandon it.

(Photo: Illegal waste site near Haparanda)

On the premises a burn site was found and clear indications that there was an ongoing trade with scrap metal, used car parts and e-waste. Apart from that there was also information that the operator has Russian associates whom he helps with export of car parts to Russia. Available information suggested that importing car parts to Sweden and then exporting them to Russia might be part of a scheme to evade fees to Russian Customs and Excise. It was also suspected that some of the discarded food including meat might be exported to Russia but declared as edible, thus causing a health hazard for potential consumers. On the premises the inspectors also found meat and dairy products stored outdoors and attracting rats and birds. The estate as a whole was covered with all sorts of waste. Most of it was stored close to the main buildings but large quantities were strewn all over the estate. Apart from the waste burn site it was clear that lead batteries and various petroleum products were stored in an unsafe way. Despite the snow one could see oil spilling on the ground at various locations and suspected smash- and burn sites for burning cable.

After the inspection, the Haparanda city council decided that the operator of the site would be fined 15 000 SEK every third month until he has cleaned up the property. A criminal investigation was considered on the suspicion of environmental crime. The operator featured in local media claiming that the authorities were trying to sabotage his charity for Russia and Estonia.

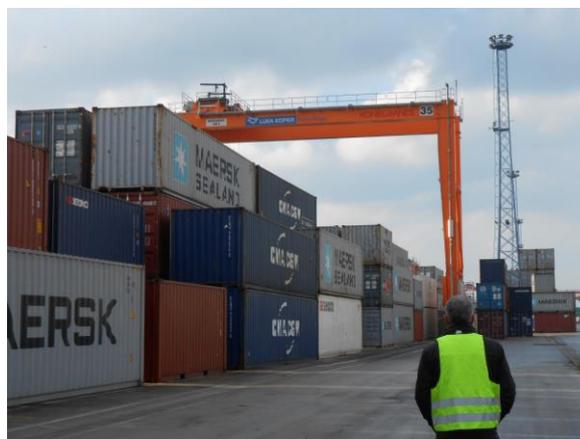
(Photo: Platform for container inspection in the port of Koper)

At the container inspection platform 11 containers were selected for checking, on the basis of a risk analysis by customs authorities. In 10 cases the containers were loaded with different types of plastic waste, in the 11th case the waste was brass scrap. In one case the inspectors found out that the accompanying Annex VII document was not filled in properly and that the form was not any more in use (due to amendment of the WSR by Commission Regulation (EU) No. 255/2013 of 20 March 2013). The forwarding agent was ordered to deliver the new document which should be filled in properly. With the rest of the inspected waste shipments no irregularities were found. Most of the shipments came from Italy and Slovenia. In all cases the destination countries were China or Hong Kong.

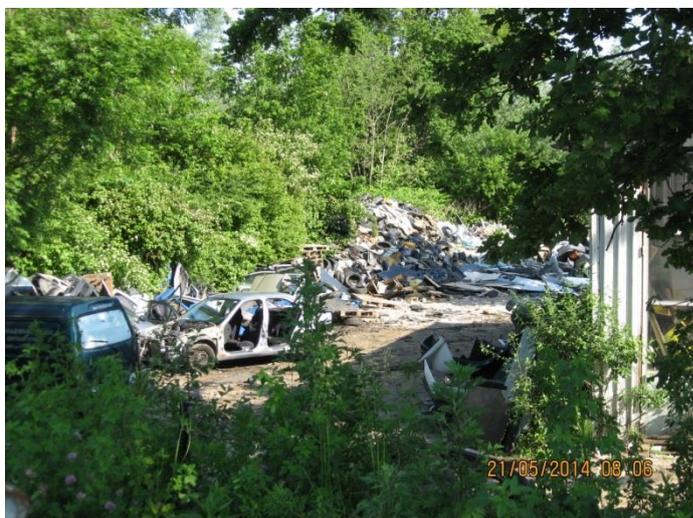
other wastes were found over an area of 12,000 m². The operator did not have any permit for waste management nor was he registered at the Environment Agency as a collector of waste. In the second location the authorities discovered large quantities of lead acid batteries, waste tyres, spare parts of cars, metal scrap and cables. During the inspection the offender was not found, so the owner of the land was interrogated by the Police. The follow-up

(Photo: Illegal waste site near Ljubjana)

measures included a prohibition by the Inspection Service to collect further waste and the order to remove all wastes on site as well as prosecutions of the offenders.

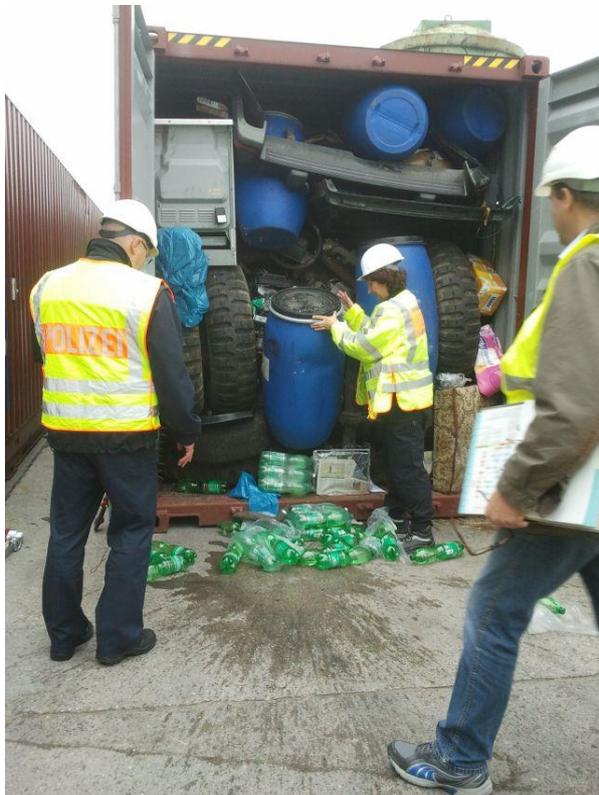
In connection with the second project team meeting on 26 September 2013, the team members could take part in the inspection of a waste container in the riverport of Gernsheim (South Hesse) on the Rhine. The inspection was preceded by an introductory briefing in the local offices of the Water Police which had the leading part in the control. The container was selected beforehand in view of its declared content (used cars) and destination (Tema in Ghana, West Africa). After a gas check by a works fireman the container was forced open at the back by the police and revealed a mixture of car parts (some of them rusty or oil-dripping), old tyres, loosely stacked electrical equipment, plastic barrels filled with smaller parts and old newspapers, water bottles and other food, as well as a range of other objects.

(Photo: Container check in Gernsheim, Germany)

There was no mobile scanner available for this control, so that the non-visible inside of the container could not be inspected. The damaged and dirty condition of the scrap parts in the visible area, the lack of documentation on functionality of the electrical equipment and the unsecured loading led the experts present to the view that this was a waste shipment and as such illegal. However, the competent authority of dispatch in the German state of Rhineland-Palatinate, which was contacted on the spot, tended to reject this classification and the consequential return to the place of dispatch as long as the non-functionality of the EEE had not been proved by tests on the spot. In the end, the container was released and went via Antwerp - not as declared via Rotterdam - to its destination in Ghana. As was discussed in a debriefing after the inspection, the case showed the usefulness of a targeted waste stream approach but also the need for common standards and for more cooperation between and inside EU Member States.
